Manhole Inspection Summary

Manhole # S09EE1017MH

Insp Date: **9/24/07 10:23 AM**

Location Address: **DOLFIELD AVE**

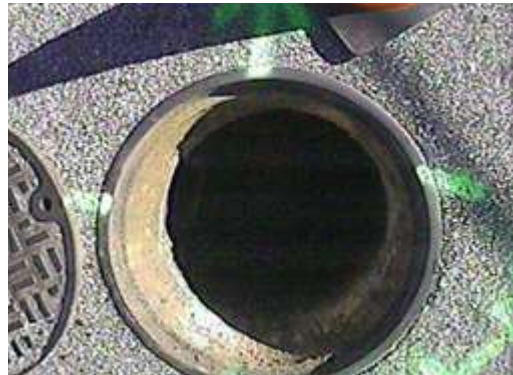
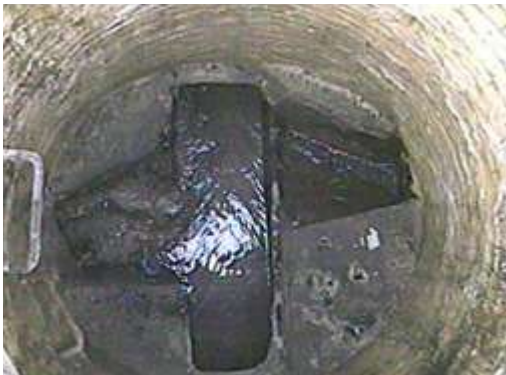
Top View

Condition: **Sound**

Condition: ☒ Sound ☐ Cracked ☐ Leaks

Condition: ☒ Sound ☐ Cracked ☐ Root Intrusion ☐ Loose Brick ☐ Deteriorated

Condition: ☒ Sound ☐ Cracked ☐ Root Intrusion ☐ Deteriorated ☐ Leaks ☐ Debris

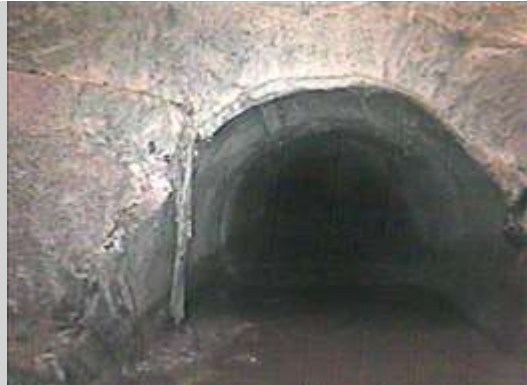
12 O'Clock Outflow

15 in. Circular Gravity Sewer
Pipe Out @ 12 O'Clock

Pipe Height: **10.8** (in.) Rod and Bar
Pipe Material: **Clay** ☐ Pipe Lined
Invert Depth: **10.13** (ft.) Flow Characteristics: **Fast**
Deposits: ☒ None ☐ Mud ☐ Sludge ☐ Debris ☐ Grease
Silt Depth: (in.) Deposits Extent:
Infiltration: **None** Pipe Seal Cond: **Sound**

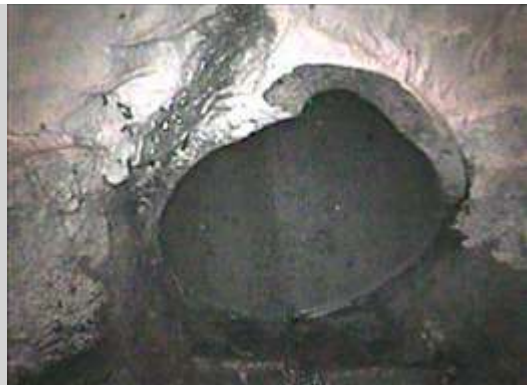
3 O'Clock Inflow

8 in. Circular Gravity Sewer
Pipe In @ 3 O'Clock

Pipe Height: (in.) Direct
Pipe Material: **Clay** ☐ Pipe Lined
Invert Depth: **8.97** (ft.) Flow Characteristics: **Slow**
Deposits: ☒ None ☐ Mud ☐ Sludge ☐ Debris ☐ Grease
Silt Depth: (in.) Deposits Extent:
Infiltration: **None** Pipe Seal Cond: **Broken**

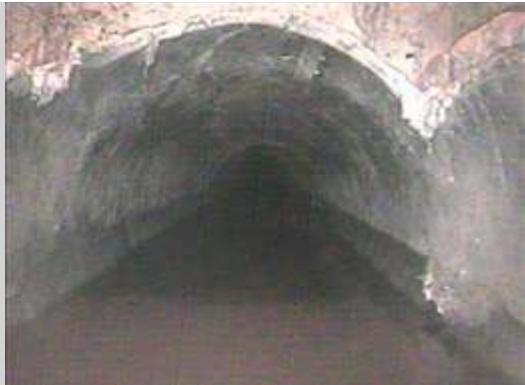
6 O'Clock Inflow

15 in. Circular Gravity Sewer

Pipe In @ 6 O'Clock

Infiltration: **None** Pipe Seal Cond: **Sound**

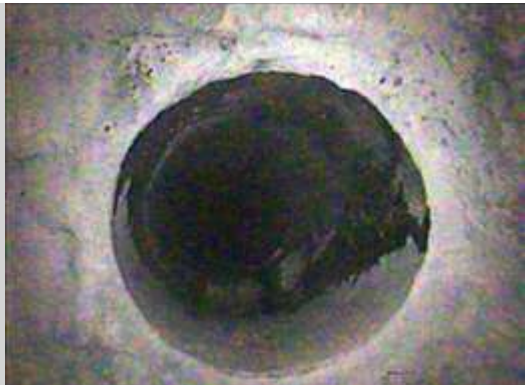
9 O'Clock Inflow

8 in. Circular Gravity Sewer

Pipe In @ 9 O'Clock

Infiltration: **None** Pipe Seal Cond: **Cracked**

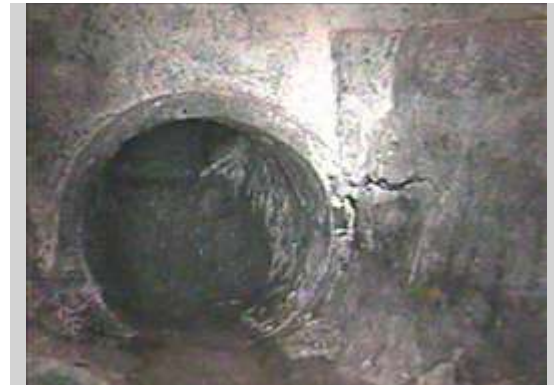
Drop In @ 9 O'Clock

Drop: **Outside Direct**

Inv Depth: **9.03** (ft.)

Drop Condition: **Open**
